# **The 2011 off the Pacific coast of Tohoku Pacific Earthquake and the seismic damage to the NPPs**

4<sup>th</sup> April, 2011

Nuclear and Industrial Safety Agency (NISA)  
Japan Nuclear Energy Safety Organization (JNES)

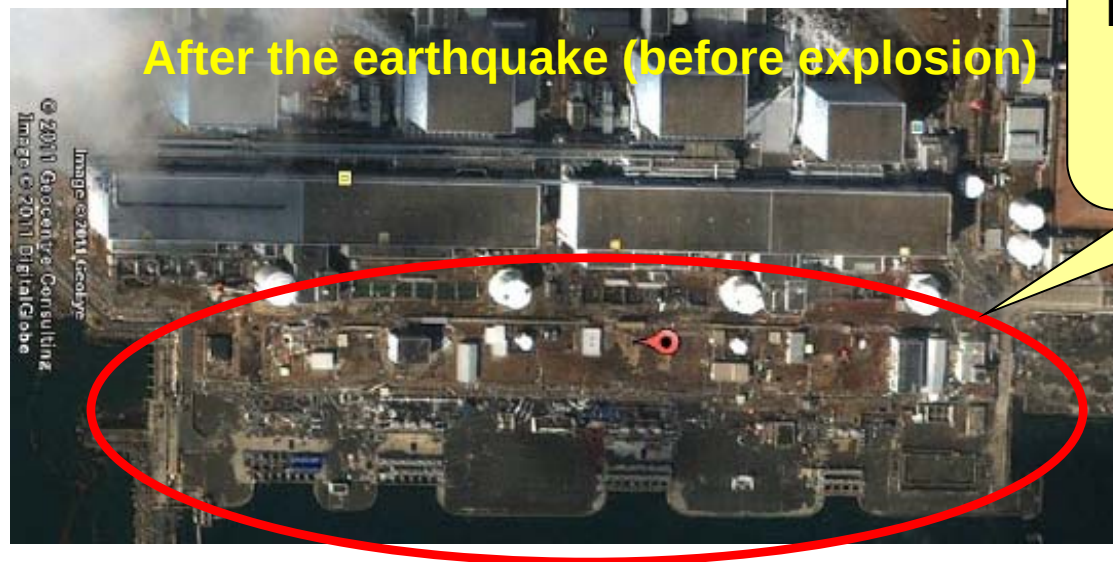
### 3-1. Satellite view of Fukushima Dai-ichi NPP

Many structures facing the bay are destroyed

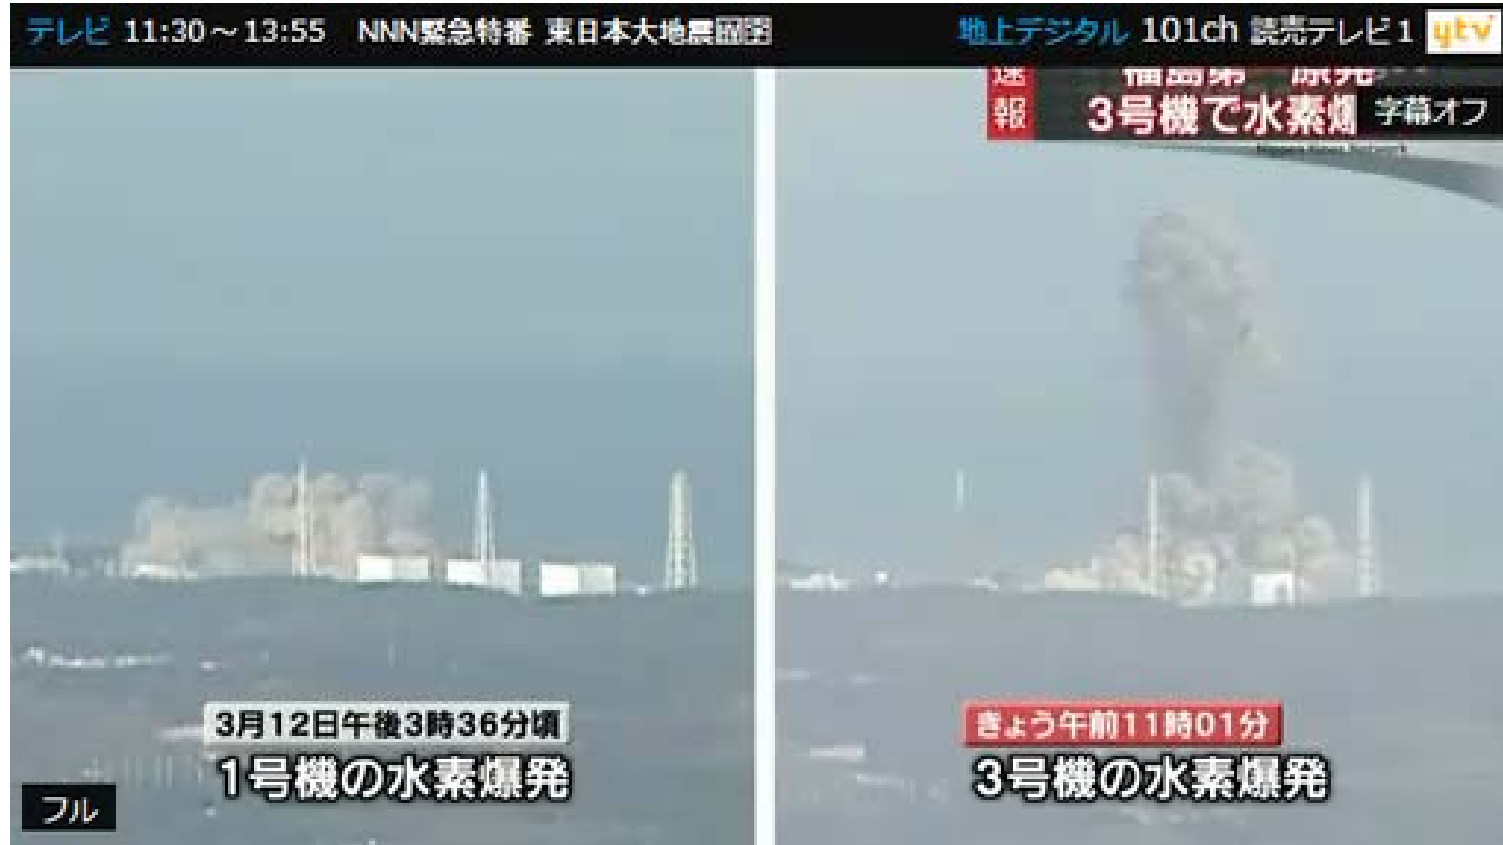
### 3-15. Hydrogen explosion at Unit 1 & 3

Unit 1

Unit 3
