# The Fukushima Daiichi Incident

1. Plant Design
2. Accident Progression
3. Radiological releases
4. Spent fuel pools
5. Sources of Information

Matthias Braun
PEPA4-G, AREVA–NP GmbH
Matthias.Braun@AREVA.com

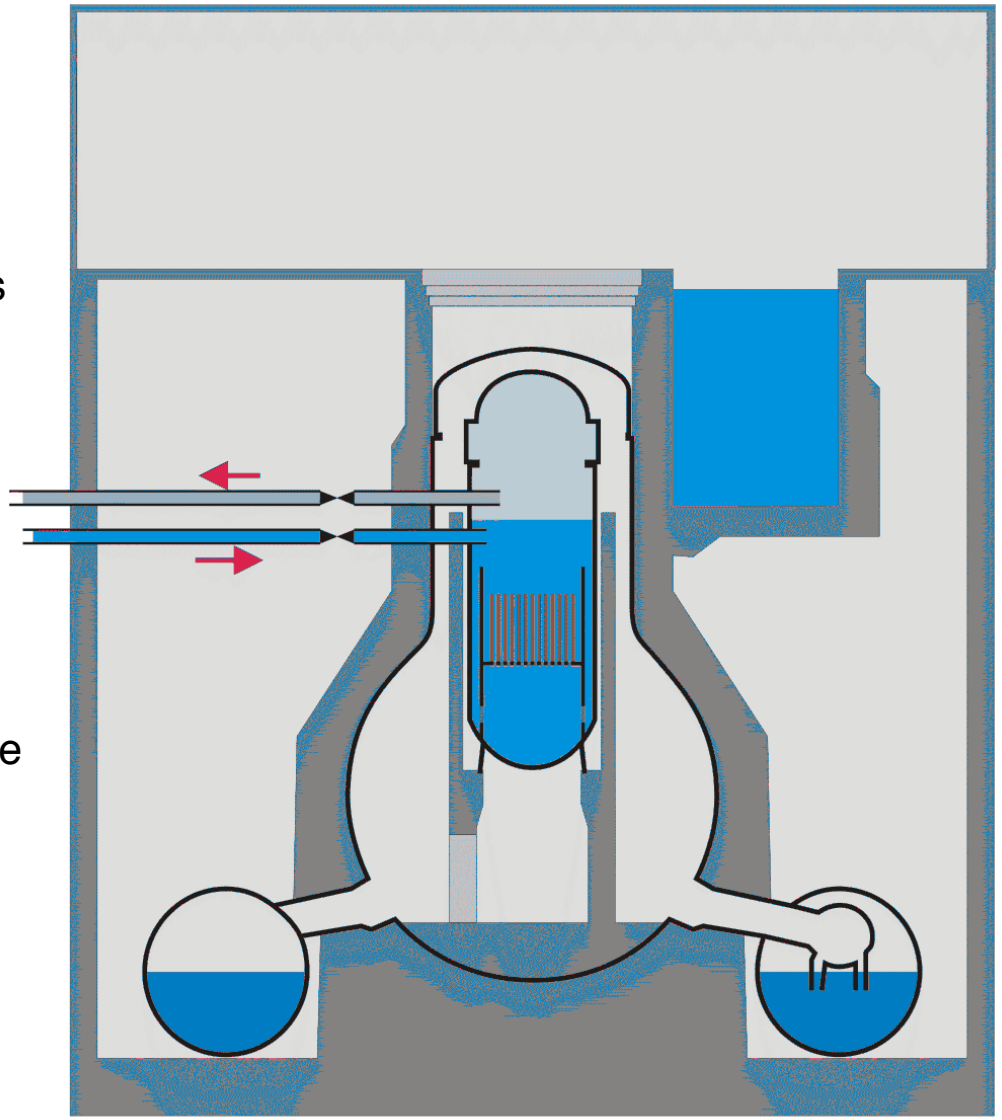
- 11.3.2011 14:46 - Earthquake
  - Magnitude 9
  - Power grid in northern Japan fails
  - Reactors itself are mainly undamaged
- SCRAM
  - Power generation due to Fission of Uranium stops
  - Heat generation due to radioactive Decay of Fission Products
    - After Scram ~6%
    - After 1 Day ~1%
    - After 5 Days ~0.5%

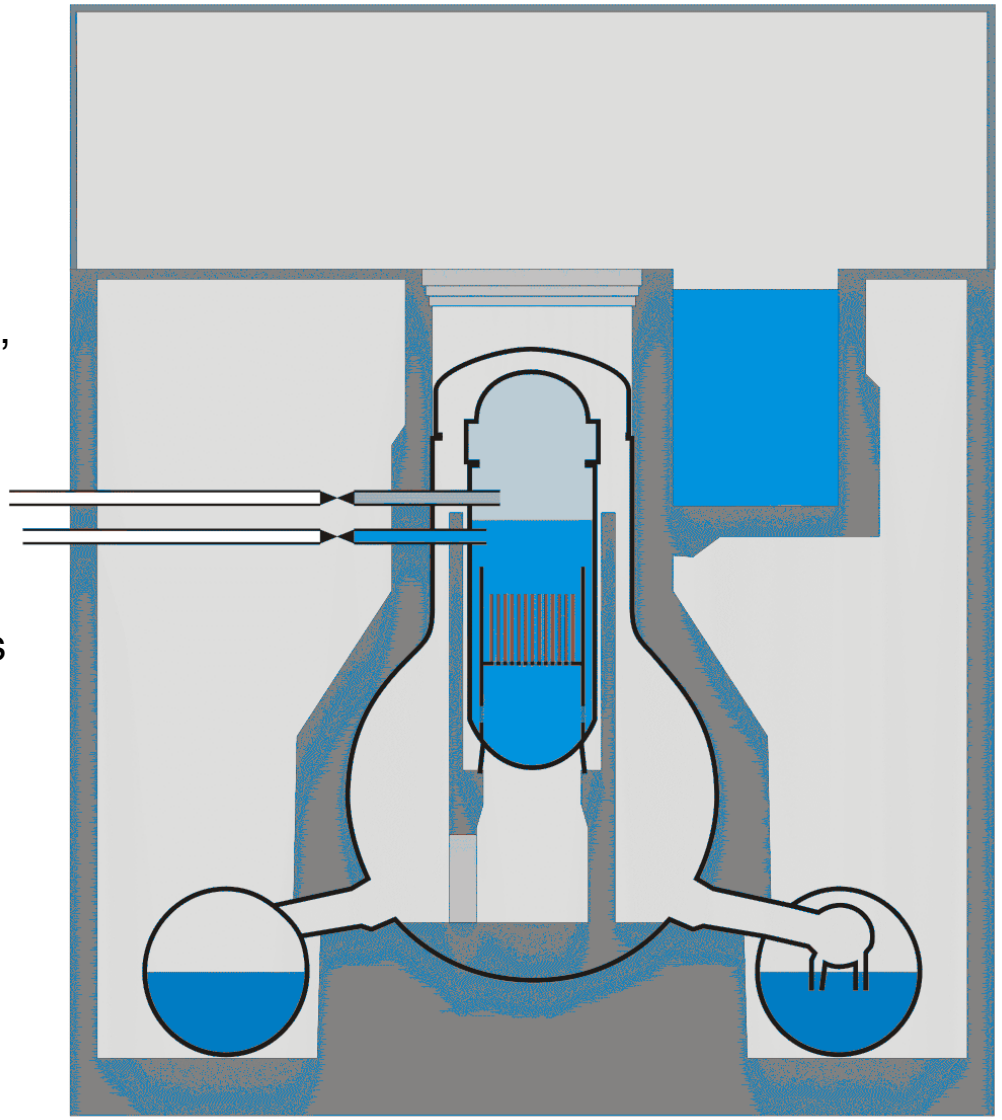
- Containment Isolation
  - Closing of all non-safety related Penetrations of the containment
  - Cuts off Machine hall
  - If containment isolation succeeds, a large early release of fission products is highly unlikely
- Diesel generators start
  - Emergency Core cooling systems are supplied
- Plant is in a stable save state

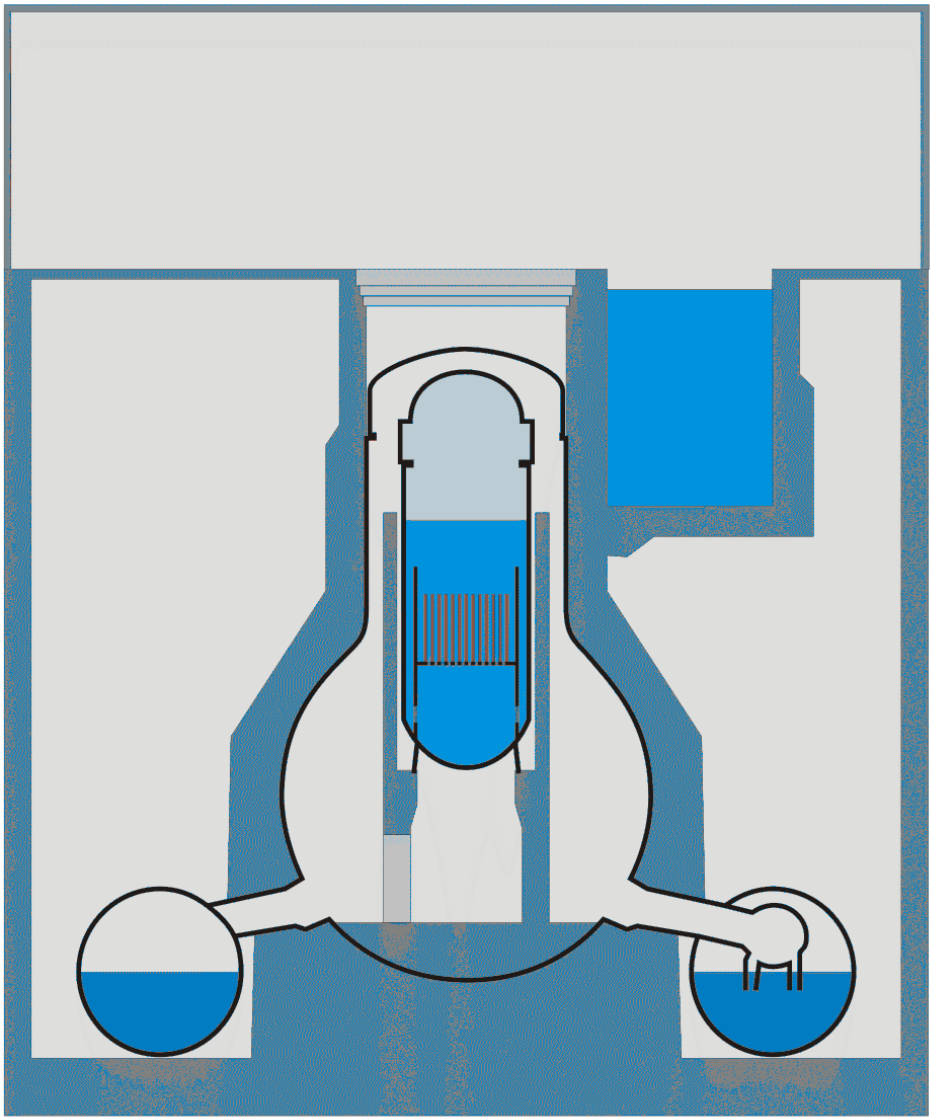
- 11.3. 15:41 Tsunami hits the plant
  - Plant Design for Tsunami height of up to 6.5m
  - Actual Tsunami height >7m
  - Flooding of
    - Diesel Generators and/or
    - Essential service water building cooling the generators
- Station Blackout
  - Common cause failure of the power supply
  - Only Batteries are still available
  - Failure of all but one Emergency core cooling systems

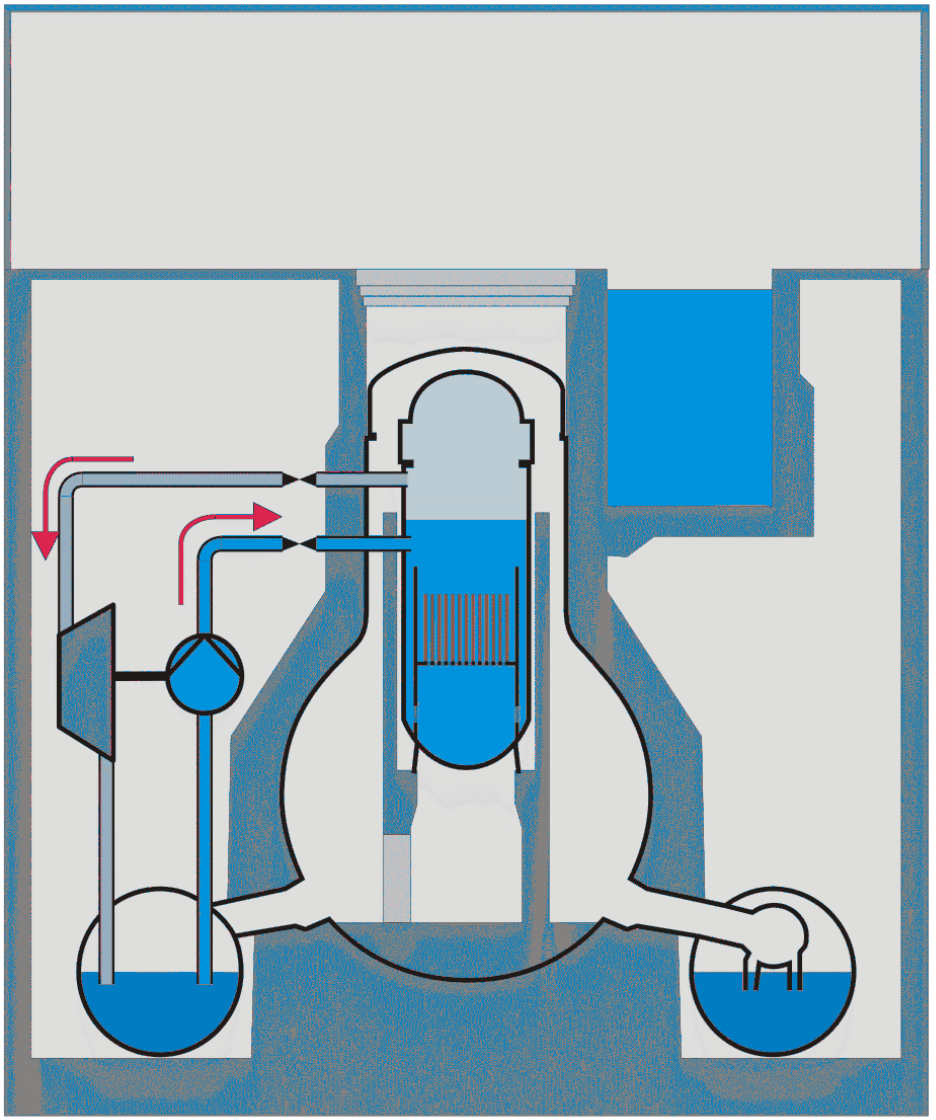
- Reactor Core Isolation Pump still available
  - Steam from the Reactor drives a Turbine
  - Steam gets condensed in the Wet-Well
  - Turbine drives a Pump
  - Water from the Wet-Well gets pumped in Reactor
  - Necessary:
    - Battery power
    - Temperature in the wet-well must be below 100℃
- As there is no heat removal from the building, the Core isolation pump cant work infinitely

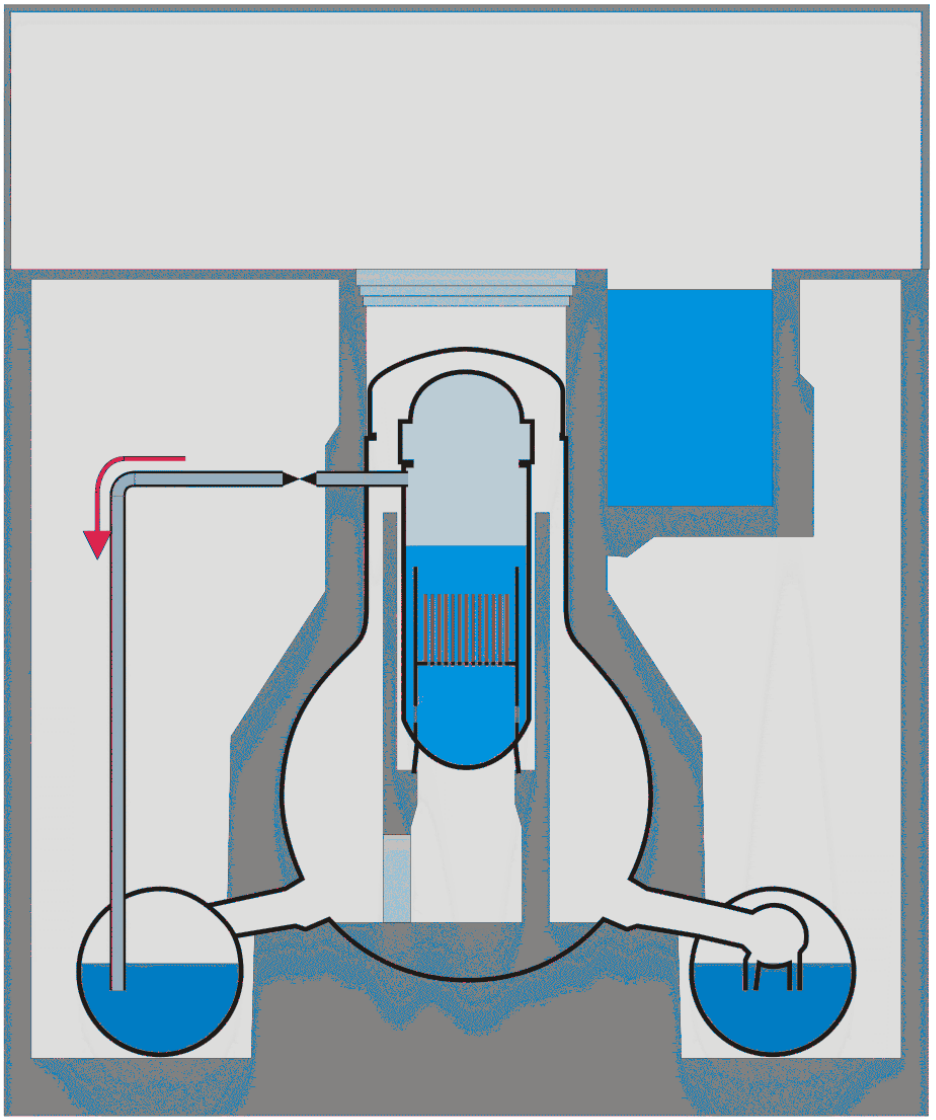
- Reactor Isolation pump stops
  - 11.3. 16:36 in Unit 1 (Batteries empty)
  - 14.3. 13:25 in Unit 2 (Pump failure)
  - 13.3. 2:44 in Unit 3 (Batteries empty)
- Decay Heat produces still steam in Reactor pressure Vessel
  - Pressure rising
- Opening the steam relieve valves
  - Discharge Steam into the Wet-Well
- Descending of the Liquid Level in the Reactor pressure vessel

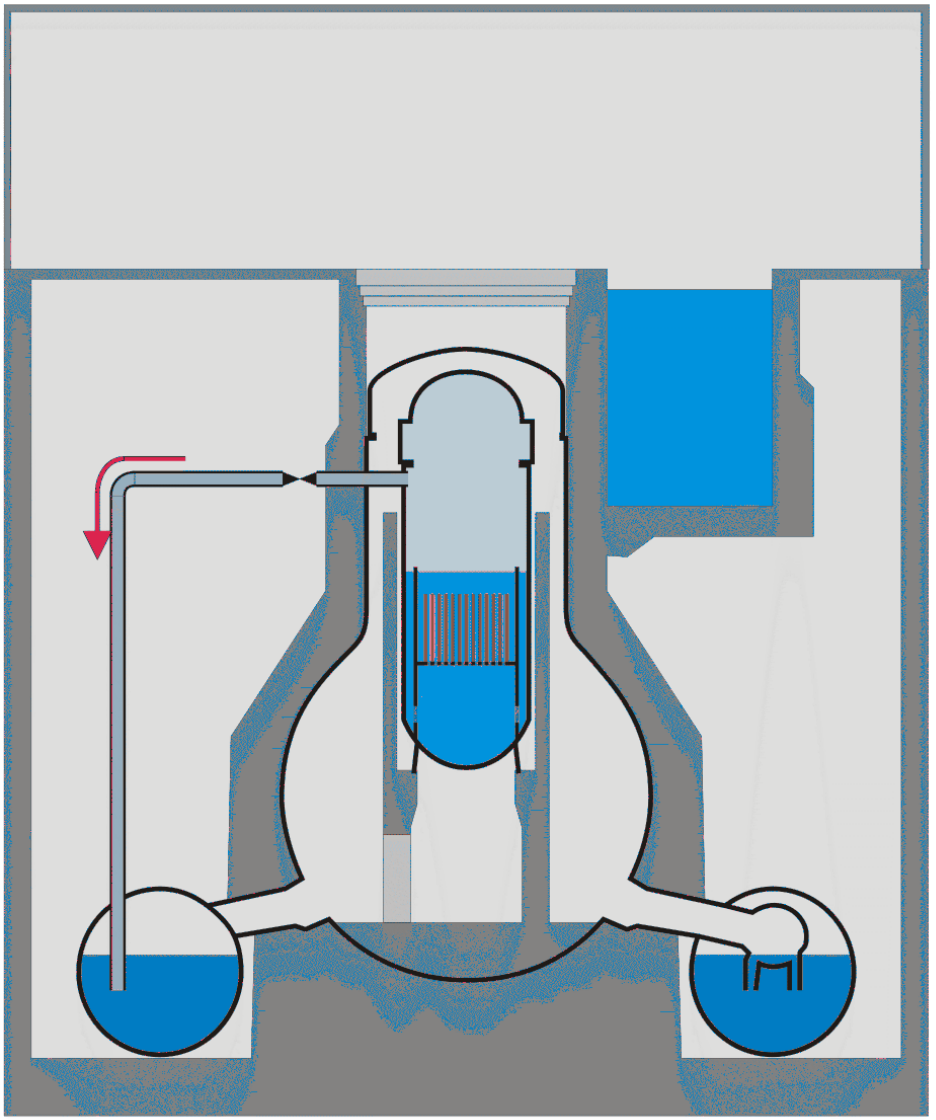
- Reactor Isolation pump stops
  - 11.3. 16:36 in Unit 1 (Batteries empty)
  - 14.3. 13:25 in Unit 2 (Pump failure)
  - 13.3. 2:44 in Unit 3 (Batteries empty)
- Decay Heat produces still steam in Reactor pressure Vessel
  - Pressure rising
- Opening the steam relieve valves
  - Discharge Steam into the Wet-Well
- Descending of the Liquid Level in the Reactor pressure vessel

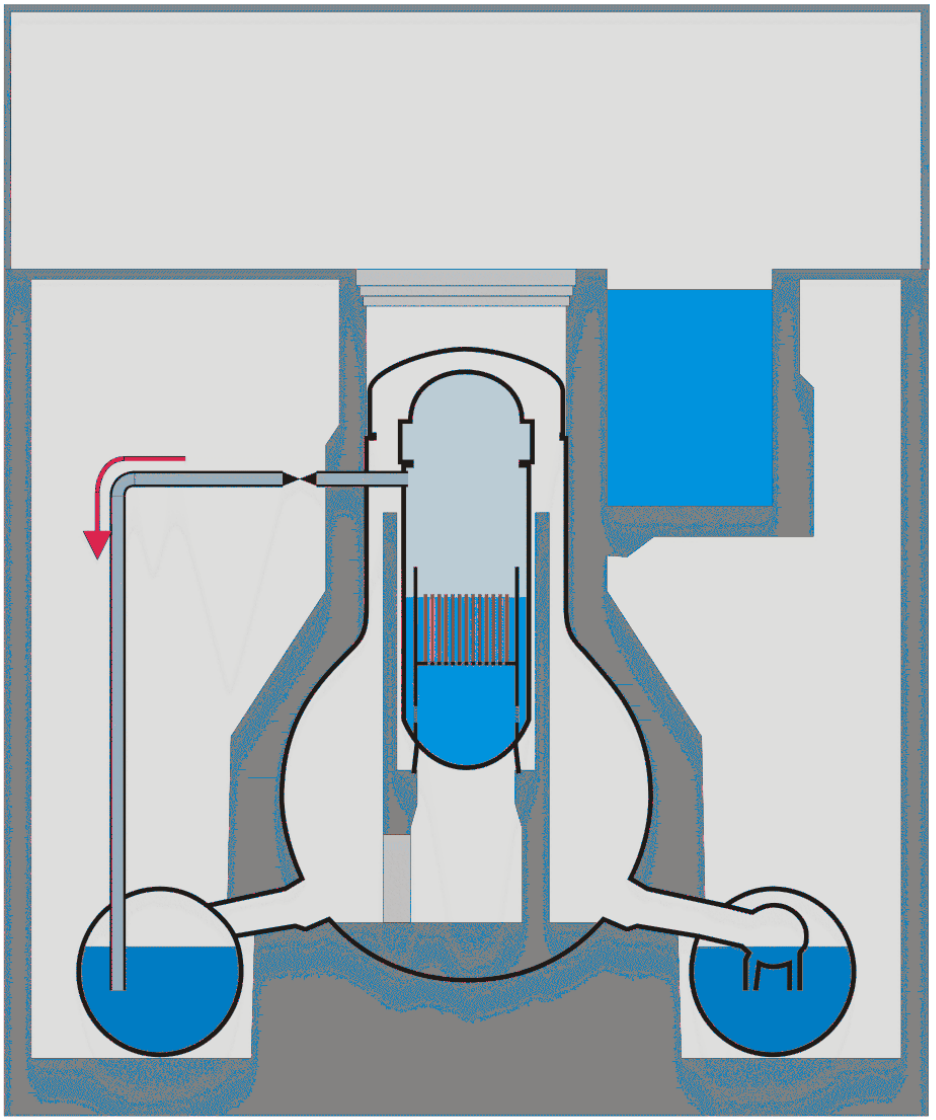
- Reactor Isolation pump stops
  - 11.3. 16:36 in Unit 1 (Batteries empty)
  - 14.3. 13:25 in Unit 2 (Pump failure)
  - 13.3. 2:44 in Unit 3 (Batteries empty)
- Decay Heat produces still steam in Reactor pressure Vessel
  - Pressure rising
- Opening the steam relieve valves
  - Discharge Steam into the Wet-Well
- Descending of the Liquid Level in the Reactor pressure vessel

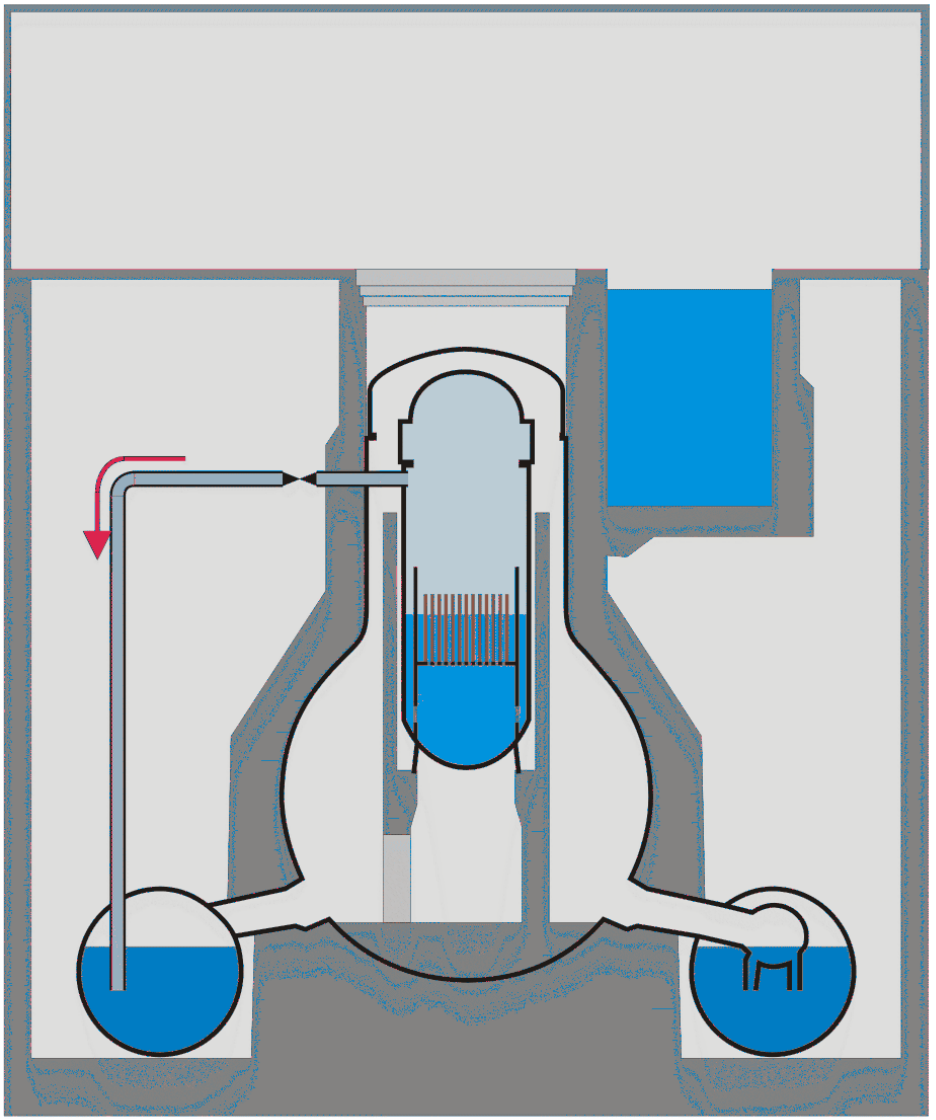
- Reactor Isolation pump stops
  - 11.3. 16:36 in Unit 1 (Batteries empty)
  - 14.3. 13:25 in Unit 2 (Pump failure)
  - 13.3. 2:44 in Unit 3 (Batteries empty)
- Decay Heat produces still steam in Reactor pressure Vessel
  - Pressure rising
- Opening the steam relieve valves
  - Discharge Steam into the Wet-Well
- Descending of the Liquid Level in the Reactor pressure vessel

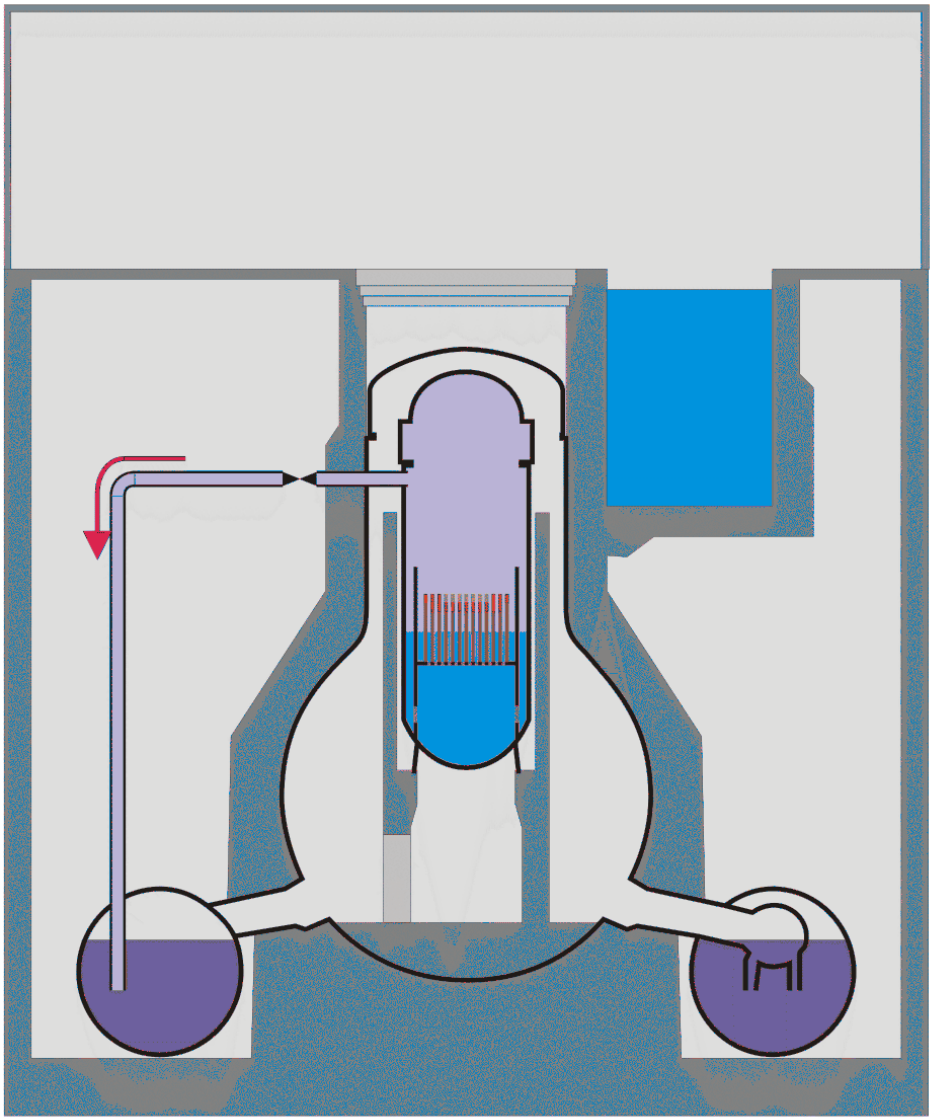
- Measured, and here referenced Liquid level is the collapsed level. The actual liquid level lies higher due to the steam bubbles in the liquid

- ~50% of the core exposed
  - Cladding temperatures rise, but still no significant core damage

- ~2/3 of the core exposed
  - Cladding temperature exceeds ~900℃
  - Balooning / Breaking of the cladding
  - Release of fission products form the fuel rod gaps

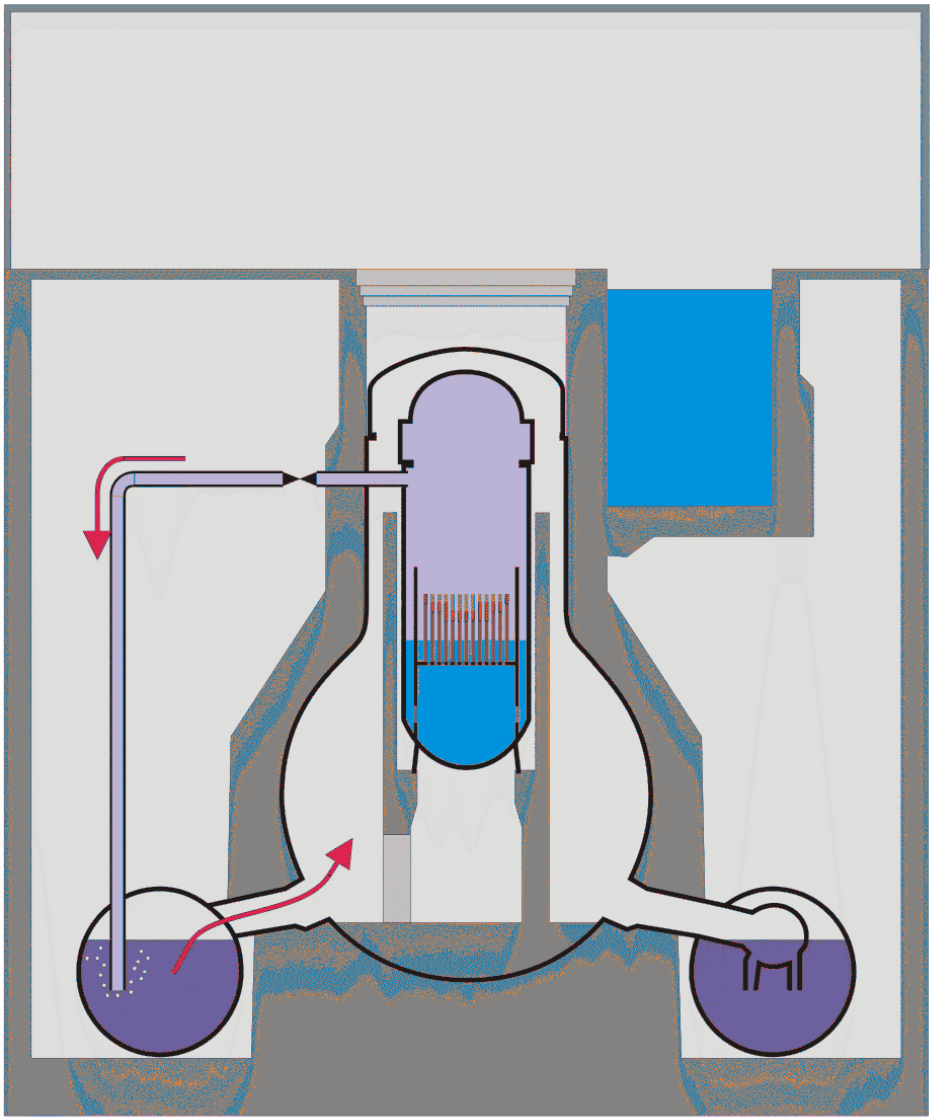
- ~3/4 of the core exposed
  - Cladding exceeds ~1200℃
  - Zirconium in the cladding starts to burn under Steam atmosphere
  - **$Zr + 2H_20 \rightarrow ZrO_2 + 2H_2$**
  - Exothermal reaction further heats the core
  - Generation of hydrogen
    - Unit 1: 300-600kg
    - Unit 2/3: 300-1000kg
  - Hydrogen gets pushed via the wet-well, the wet-well vacuum breakers into the dry-well

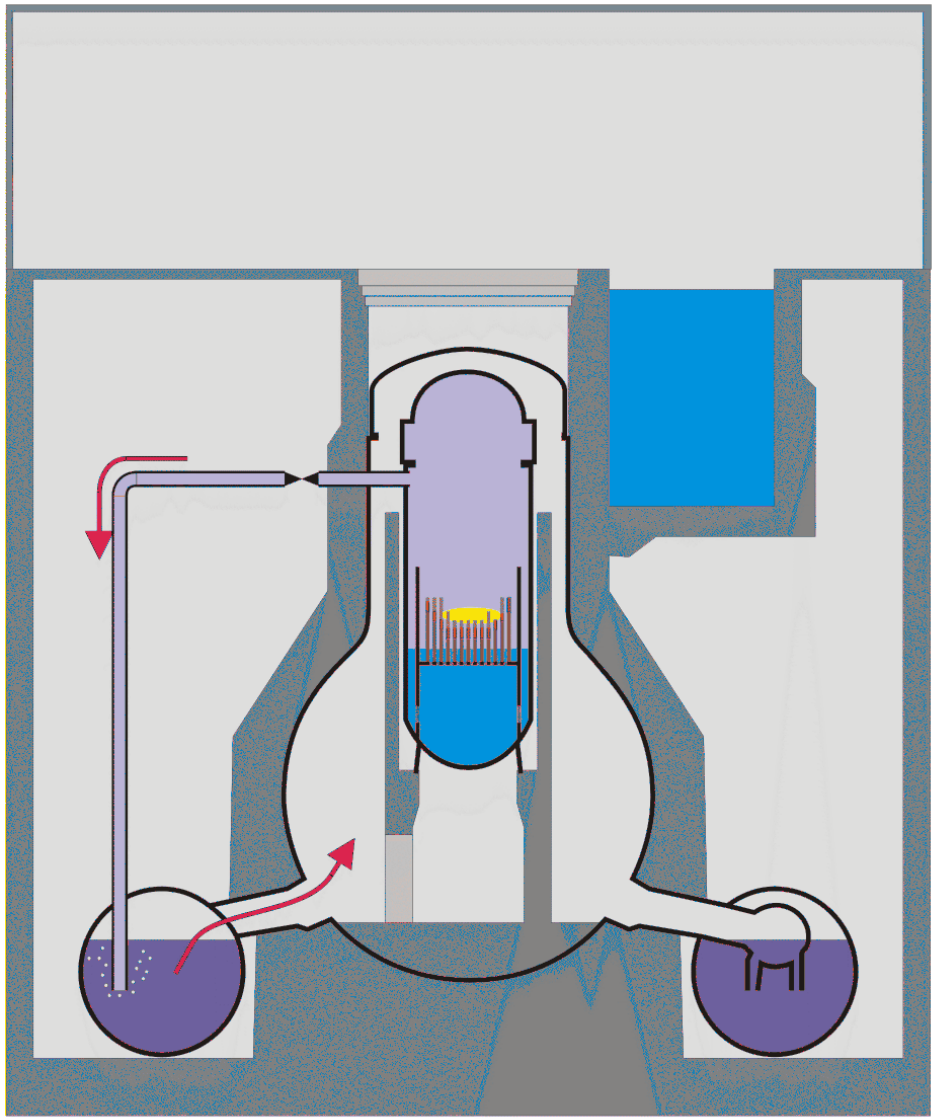
- at ~1800℃ [Unit 1,2,3]
  - Melting of the Cladding
  - Melting of the steel structures
- at ~2500℃ [Block 1,2]
  - Breaking of the fuel rods
  - debris bed inside the core
- at ~2700℃ [Block 1]
  - Melting of Uranium-Zirconium eutectics
- Restoration of the water supply stops accident in all 3 Units
  - Unit 1: 12.3. 20:20 (27h w.o. water)
  - Unit 2: 14.3. 20:33 (7h w.o. water)
  - Unit 3: 13.3. 9:38 (7h w.o. water)

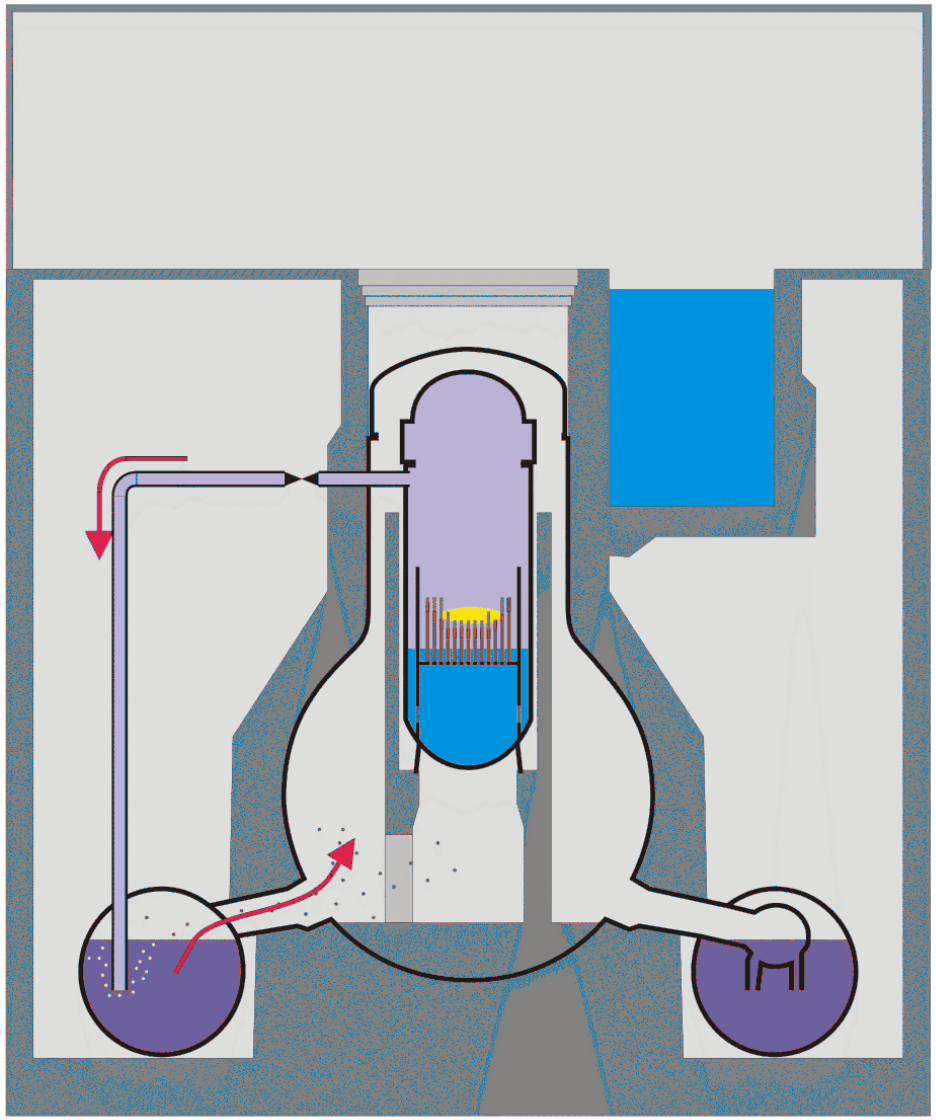
- Release of fission products during melt down
  - Xenon, Cesium, Iodine,…
  - Uranium/Plutonium remain in core
  - Fission products condensate to airborne Aerosols
- Discharge through valves into water of the condensation chamber
  - Pool scrubbing binds a fraction of Aerosols in the water
- Xenon and remaining aerosols enter the Dry-Well
  - Deposition of aerosols on surfaces further decontaminates air

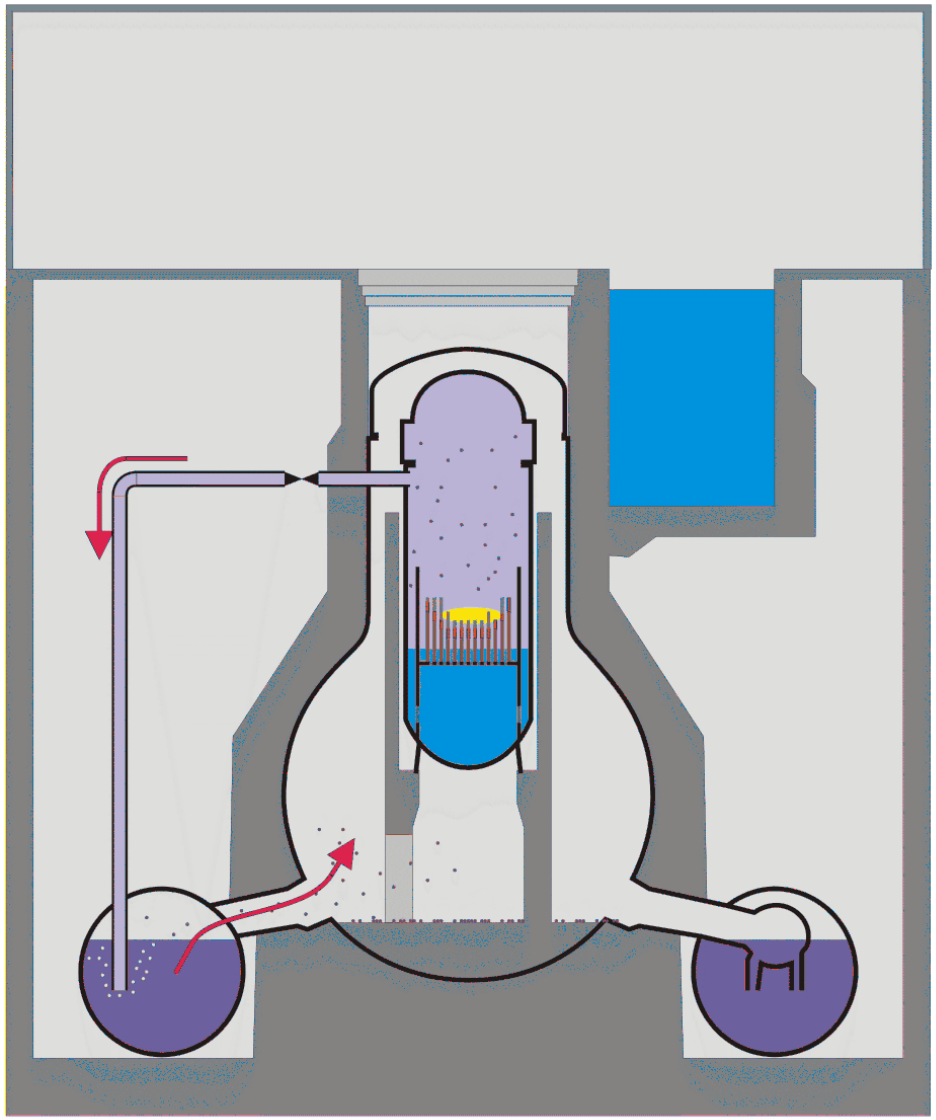
- Containment
  - Last barrier between Fission Products and Environment
  - Wall thickness ~3cm
  - Design Pressure 4-5bar
- Actual pressure up to 8 bars
  - Normal inert gas filling (Nitrogen)
  - Hydrogen from core oxidation
  - Boiling condensation chamber (like a pressure cooker)
- Depressurization of the containment
  - Unit 1: 12.3. 4:00
  - Unit 2: 13.3 00:00
  - Unit 3: 13.3. 8.41

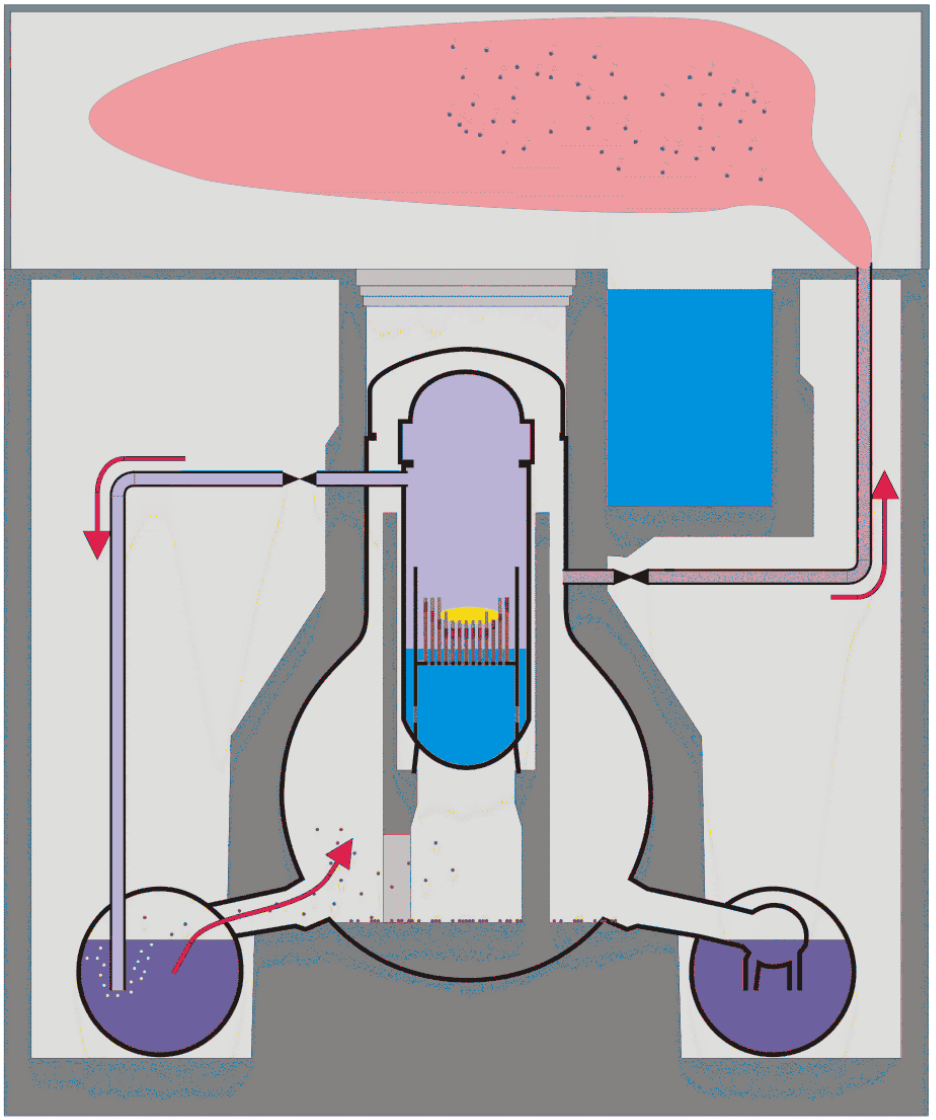
- Positive und negative Aspects of depressurizing the containment
  - Removes Energy from the Reactor building (only way left)
  - Reducing the pressure to ~4 bar
  - Release of small amounts of Aerosols (Iodine, Cesium ~0.1%)
  - Release of all noble gases
  - Release of Hydrogen
- Gas is released into the reactor service floor
  - Hydrogen is flammable

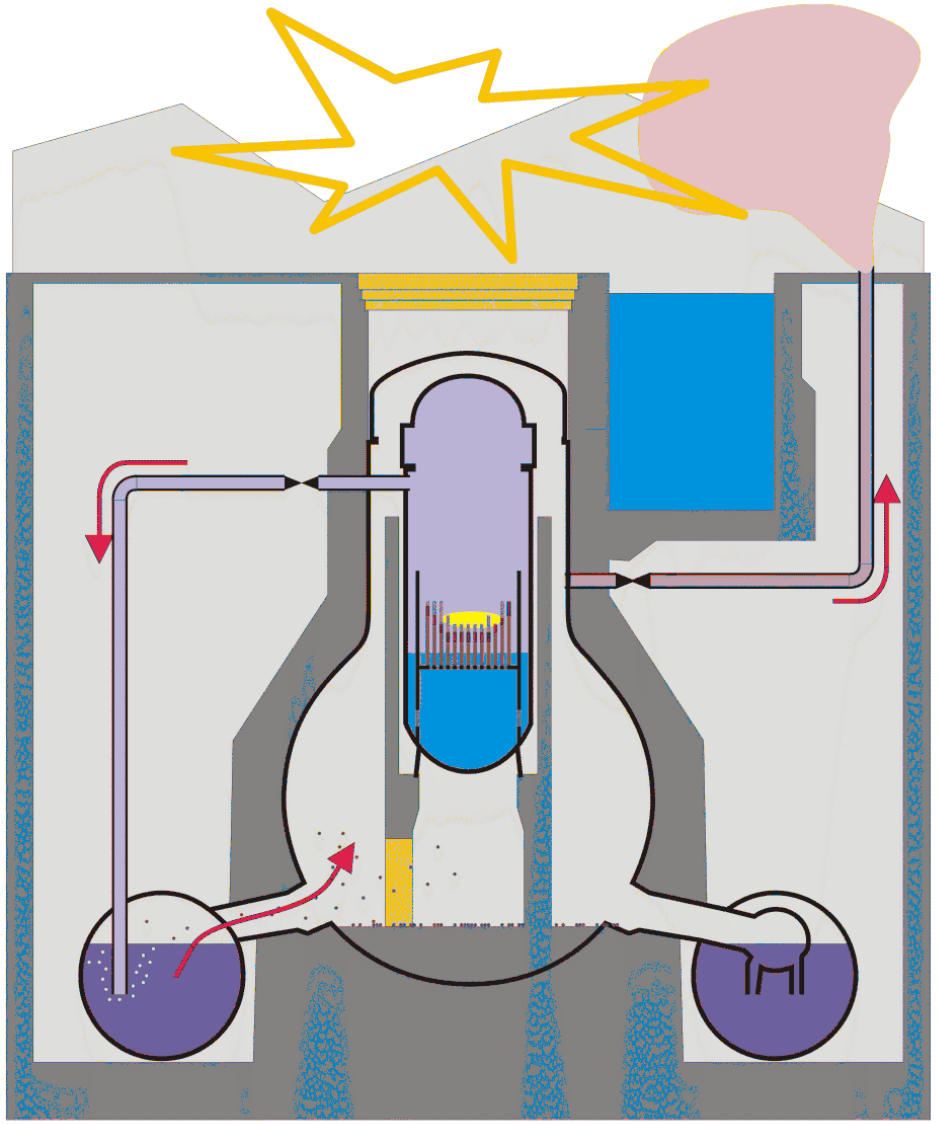
- Unit 1 und 3
  - Hydrogen burn inside the reactor service floor
  - Destruction of the steel-frame roof
  - Reinforced concrete reactor building seems undamaged
  - Spectacular but minor safety relevant

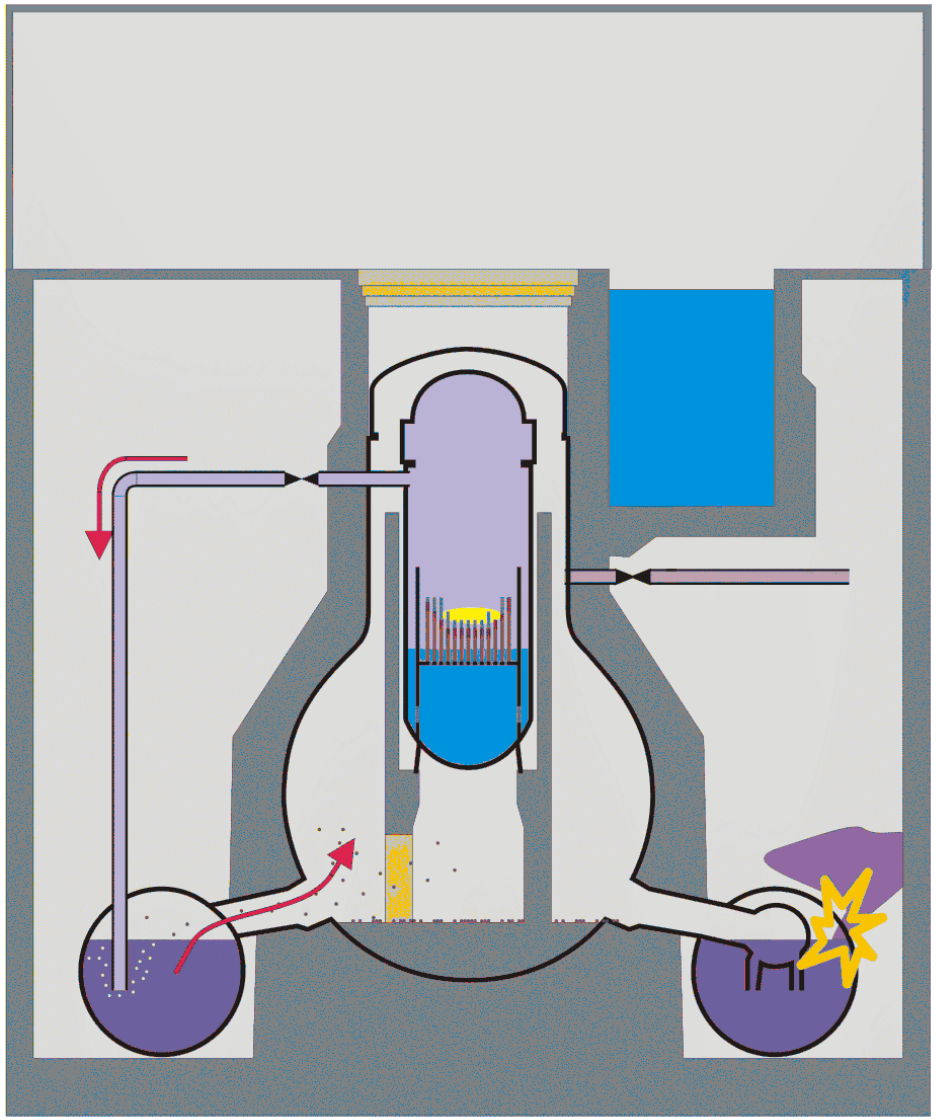
- Unit 2
  - Hydrogen burn inside the reactor building
  - Probably damage to the condensation chamber (highly contaminated water)
  - Uncontrolled release of gas from the containment
  - **Release of fission products**
  - Temporal evacuation of the plant
  - High local dose rates on the plant site due to wreckage hinder further recovery work

- No clear information's why Unit 2 behaved differently

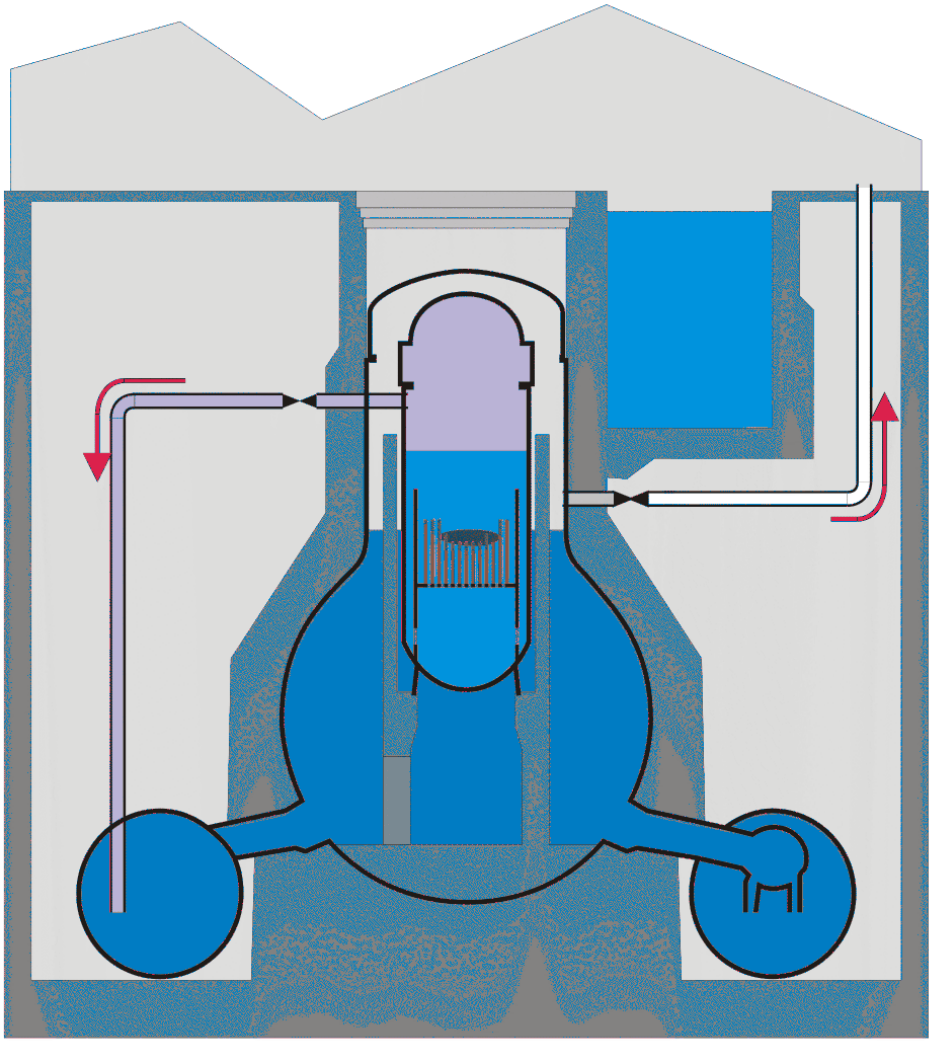
- Current status of the Reactors
  - Core Damage in Unit 1,2, 3
  - Building damage due to various burns Unit 1-4
  - Reactor pressure vessels flooded in all Units with mobile pumps
  - At least containment in Unit 1 flooded
- Further cooling of the Reactors by releasing steam to the atmosphere
- Only small further releases of fission products can be expected

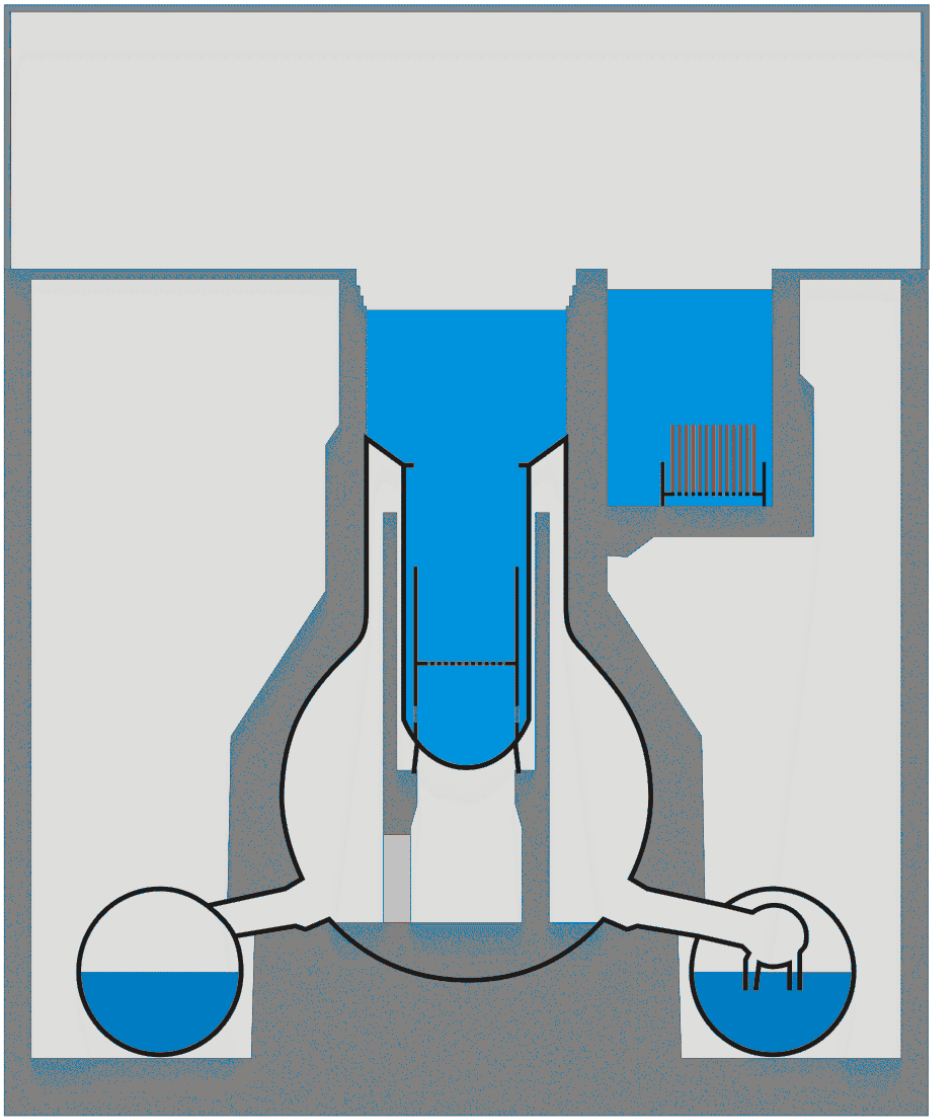
- Spend fuel stored in Pool on Reactor service floor
  - Due to maintenance in Unit 4 entire core stored in Fuel pool
  - Dry-out of the pools
    - Unit 4: in 10 days
    - Unit 1-3,5,6 in few weeks
  - **Leakage of the pools due to Earthquake?**
- Consequences
  - Core melt „on fresh air “
  - Nearly no retention of fission products
  - Large release

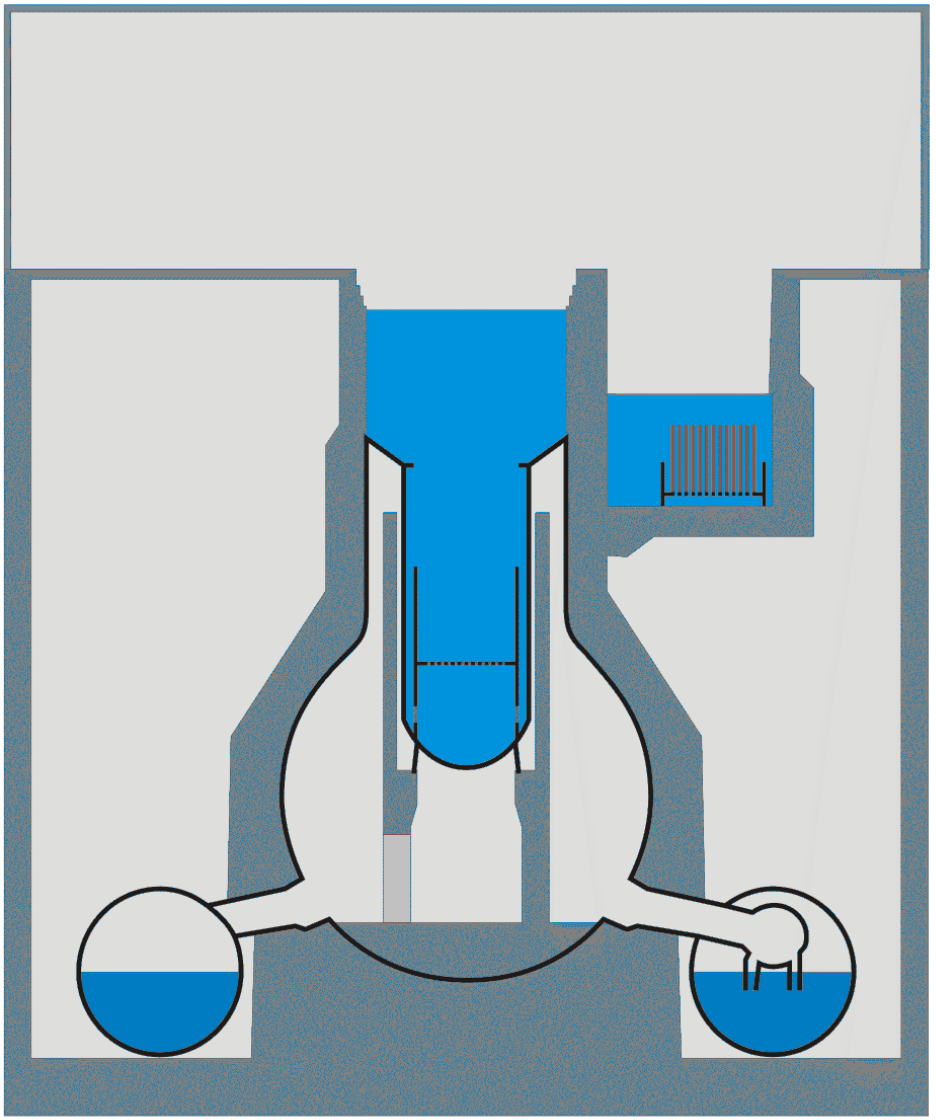
- Spend fuel stored in Pool on Reactor service floor
  - Due to maintenance in Unit 4 entire core stored in Fuel pool
  - Dry-out of the pools
    - Unit 4: in 10 days
    - Unit 1-3,5,6 in few weeks
  - **Leakage of the pools due to Earthquake?**
- Consequences
  - Core melt „on fresh air “
  - Nearly no retention of fission products
  - Large release

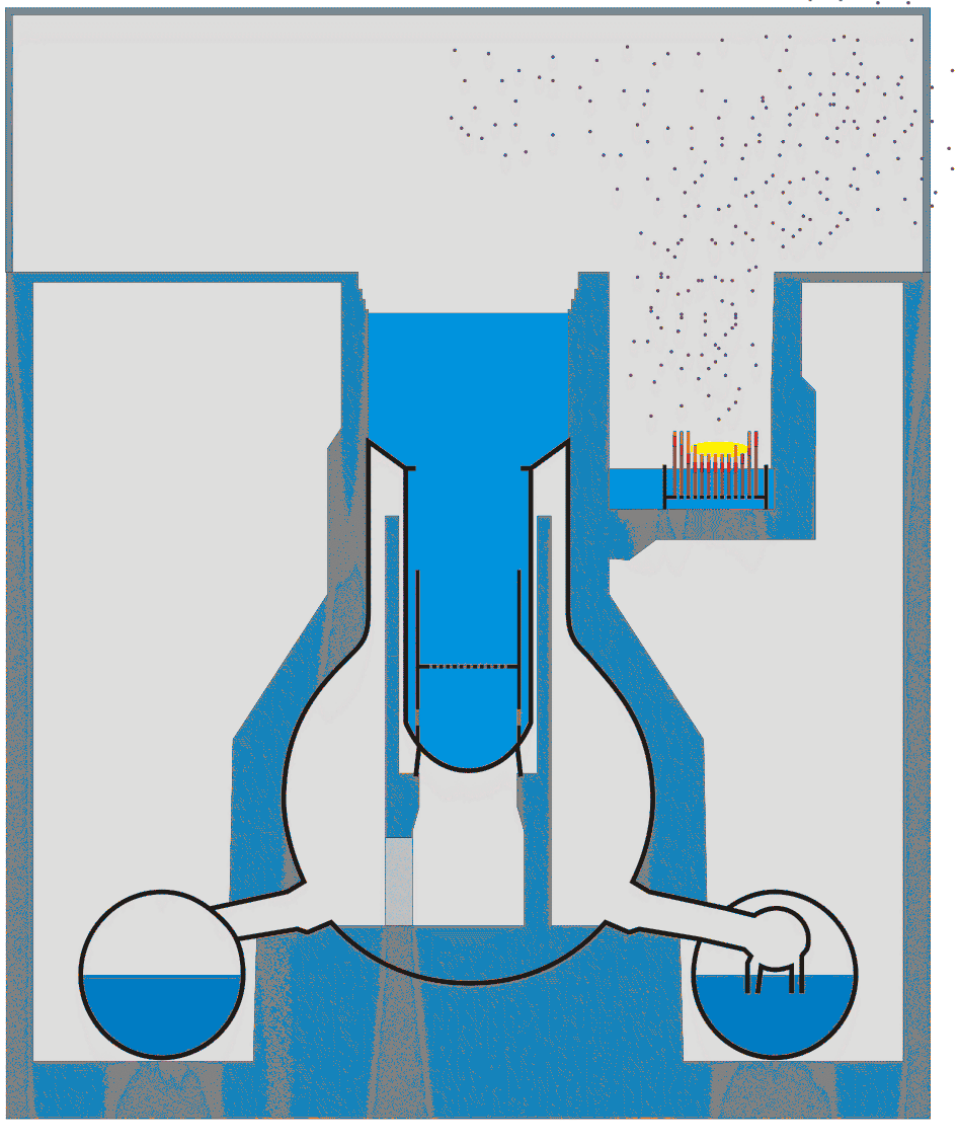
- Spend fuel stored in Pool on Reactor service floor
  - Due to maintenance in Unit 4 entire core stored in Fuel pool
  - Dry-out of the pools
    - Unit 4: in 10 days
    - Unit 1-3,5,6 in few weeks
  - **Leakage of the pools due to Earthquake?**
- Consequences
  - Core melt „on fresh air “
  - Nearly no retention of fission products
  - Large release
- **It is currently unclear if release from fuel pool already happened**
